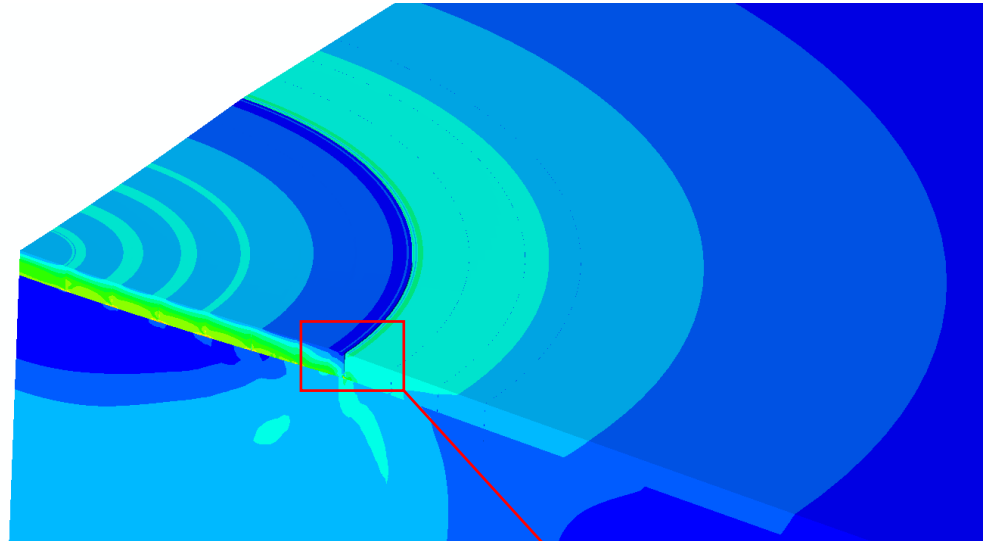
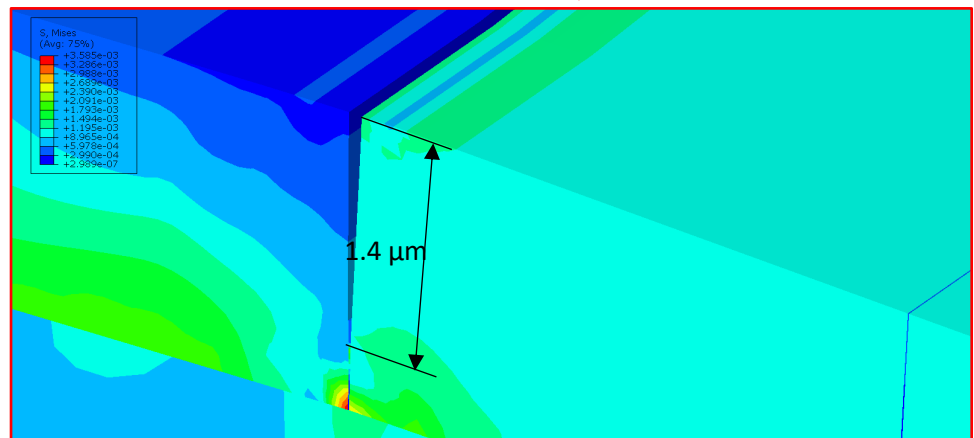
Fig. 1 At the end of cyclic loading (143th cycles), the crack reached 1.4 μm.

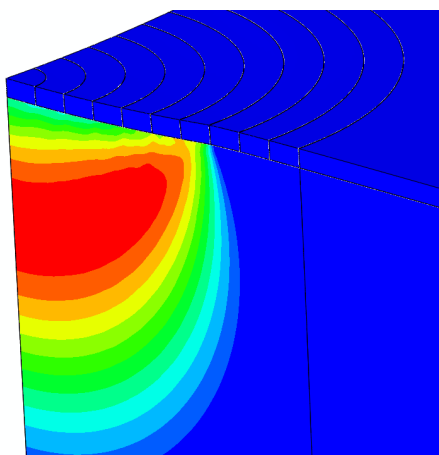
A

Fig. 2 The plastic deformation at the first loading cycle (A) and at the end of cyclic loading 143th cycles (B).
