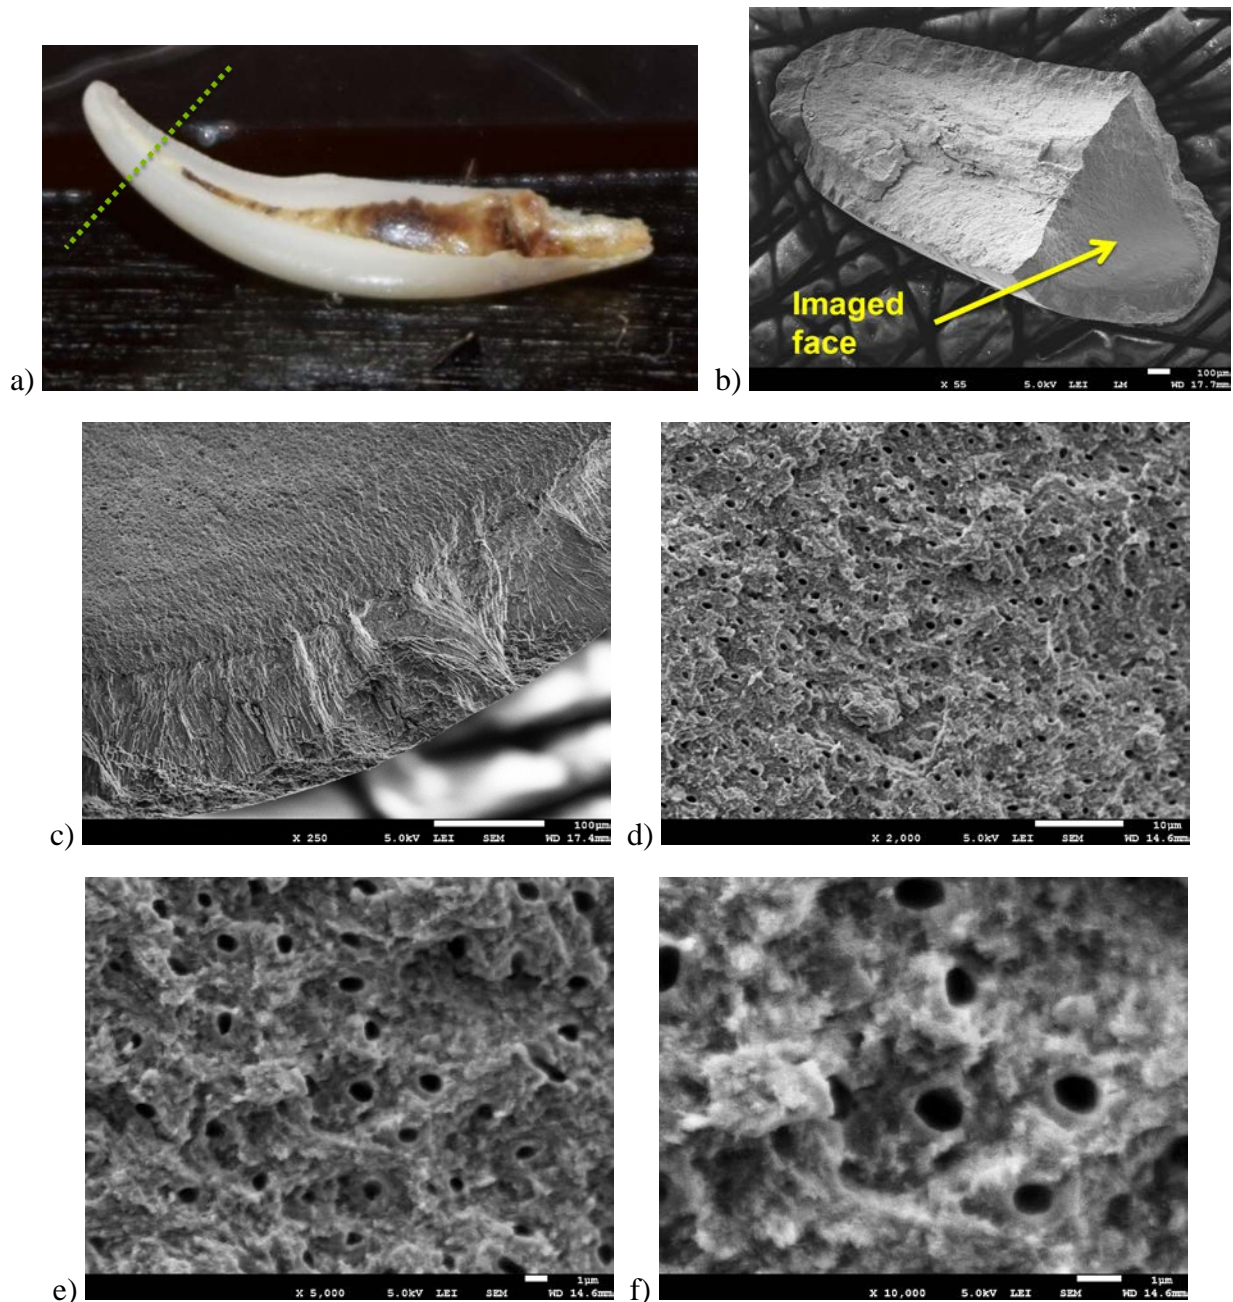
**Figure 1.** Images of SiS ZnO treated tooth sample. Tooth was treated unbroken. *After* treatment the tooth was split in half, and from the split tooth sample the tip was broken off to reveal the interior of the tooth sample. a) Optical image indicating where tip was broken. b) SEM micrograph of broken tip and indication of imaged face for images c – f. c) Image of enamel – dentin interface at 250 X magnification. Scale bar is 100  $\mu\text{m}$ . d) Image of denting region at 2 KX magnification. Scale bar is 10  $\mu\text{m}$ . e) Image of dentin region at 5 KX magnification. Scale bar is 1  $\mu\text{m}$ . f) Image of dentin region at 10 KX magnification. Scale bar is 1  $\mu\text{m}$ .
