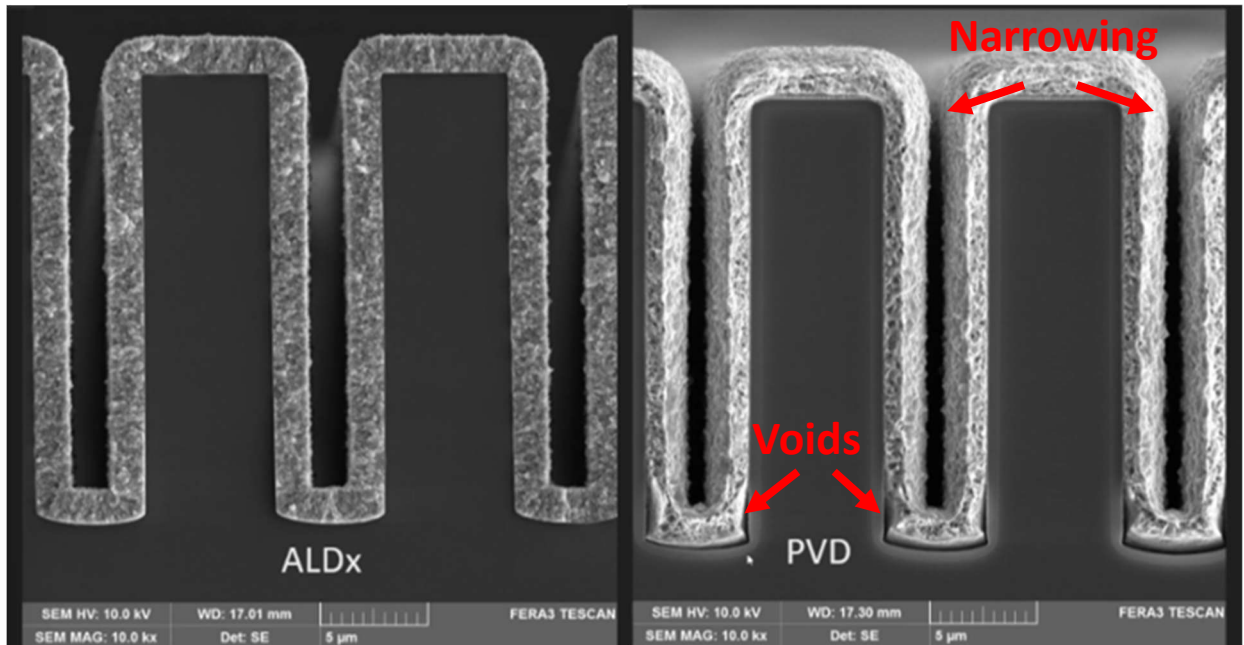
Figure 1: Scanning electron micrographs of all thermal ALD SiO, TiN, Ru stack (left) and thermal oxide, PVD Ti/W, PVD Cu stack (right) used for Cu electroplating. On the left, the total stack thickness of <math><175\text{ nm}</math> of ALD is not visible on this scale, however the fact that Cu has been electroplated and remains well adhered are evidence of success. The image on the right shows two defects resulting from the PVD Cu barrier/seed stack. The electroplating has narrowing at the top caused by a gradient in the Cu seed layer thickness and voids at the bottom, likely caused by a thin Cu adhesion layer (either Cu or Ti/W) resulting in delamination of the Cu creating a void.
