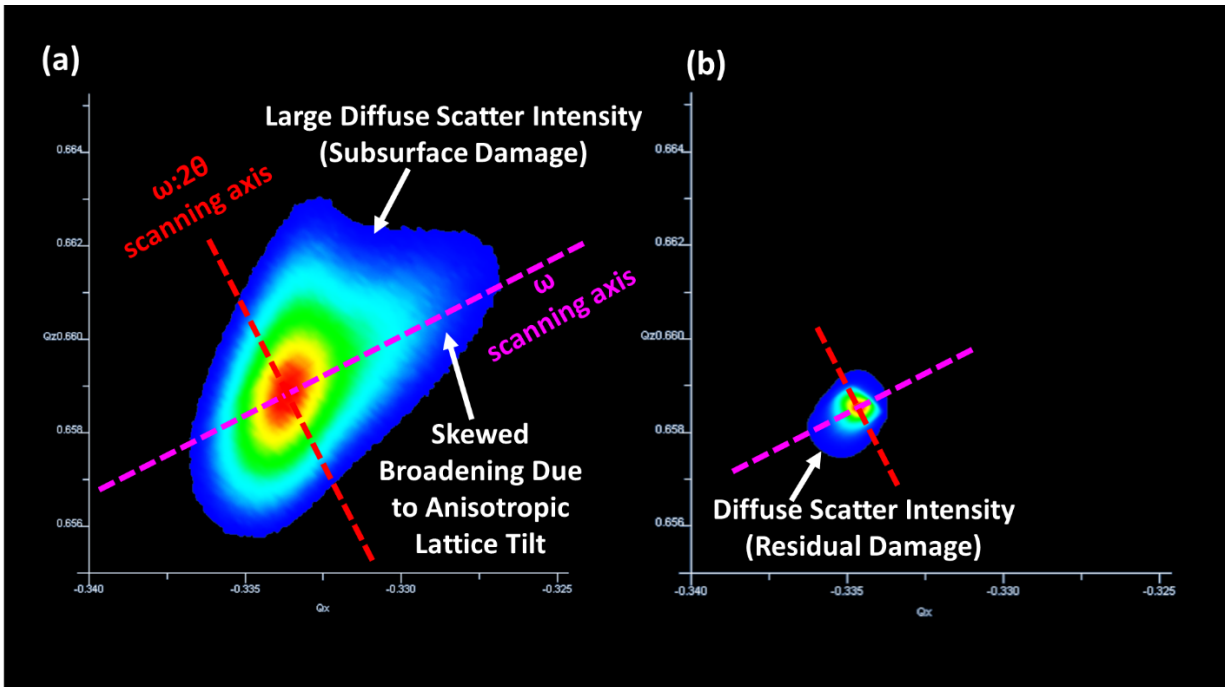
Figure 1. X-ray diffraction reciprocal space maps using the (420) reflection in glancing incidence geometry for the (a) wafer sliced rough substrate and (b) chemical mechanical polished substrate. The ω and $\omega:2\theta$ scanning axes are marked, which correspond to the directions of peak broadening due to lattice tilt and strain, respectively. The wafer sliced substrate has severe lattice damage, which is predominately lattice tilt in character. The diffuse scatter intensity is also skewed, likely indicative of the anisotropic mechanical response to deformation (damage) in $\beta\text{-Ga}_2\text{O}_3$. After polishing, the diffuse scatter intensity is significantly reduced, which corresponds to removal of subsurface damage.
